**Enhanced Preliminary
Assessment Report:**

**Bedford Army Housing Units
Bedford, Massachusetts**

September 1989

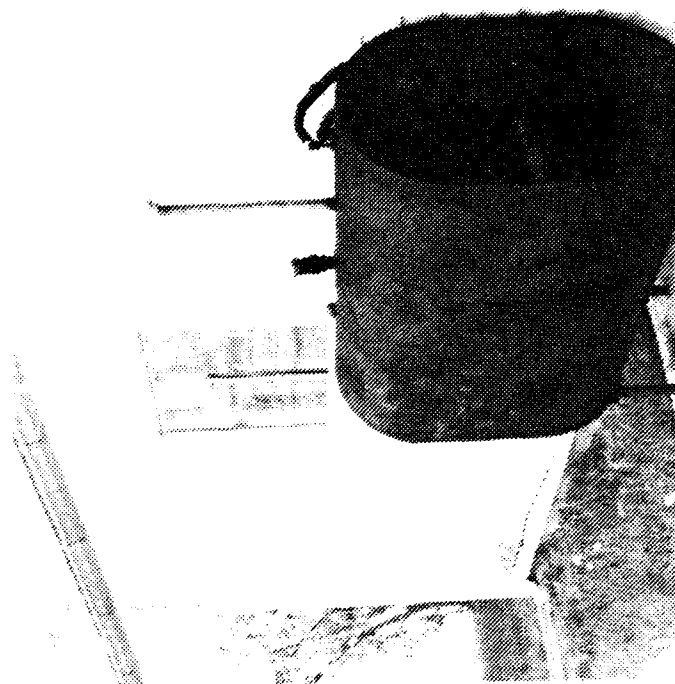
Upper left-hand photo:

Exposed insulation wrap was discovered around the water heater pipes inside one of the houses. This insulation may contain asbestos, and it was slightly deteriorated. The floor tiles are also likely to contain asbestos, but they were in good condition. It is assumed that the pipe insulations and floor tiles in the remaining units were in similar conditions.

Water pipe insulation in the one housing unit which was inspected showed signs of slight deterioration.

Slightly deteriorated water pipe insulation, which may contain asbestos, could have been the source of asbestos release to the indoor air space of the housing units.

The water pipe insulation in one of the units was slightly deteriorated. It is assumed that water pipe insulations in the remainder of the units were in similar conditions. This insulation may contain asbestos.

Deteriorating wrap around a hot water pipe, possibly asbestos-containing material.

No significant adverse environmental impacts have been associated with current operations of the Bedford housing area. Although no immediate remedial actions are warranted for the area, one action is recommended before exessing the land. Slightly deteriorated water pipe insulations in the utility rooms of the units should be removed. Such action should be preceded by a determination of whether this insulation contains asbestos, and the removal should be conducted in accordance with accepted practice if this is found to be the case.

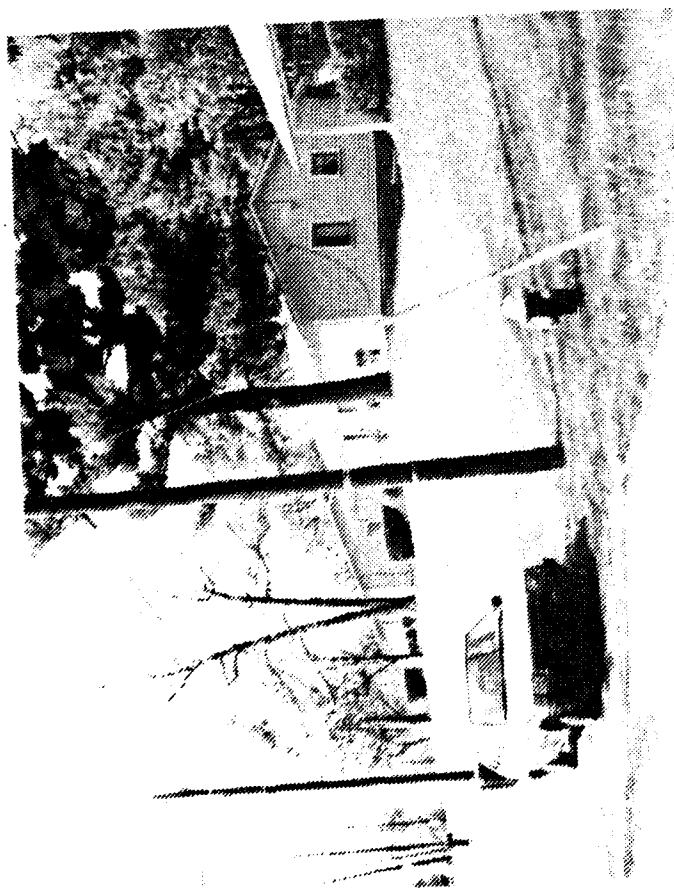
Lower right-hand photo:

The Bedford housing area was originally developed in the 1950s and consists of 5.20 acres of land.³ A playground area was filled with dumped rock to an elevation of 154 feet, from 148 feet. (A large drain opening was noticed below the playground area, in the surrounding woodland. A creek that was thought to be here is dried up. It is unclear what kind of city drainage takes place at the Bedford area.) A small part of the property, on the eastern side and adjacent to an old railroad spur, was filled for an access road.²

Playground area, believed to have been filled to present elevation.
